# **Air Accident Investigation Unit Ireland**

**SYNOPTIC REPORT**

**Unmanned Aircraft, GEN 3.8  
Tankardstown, Balbriggan, Co. Dublin**

**14 July 2022**

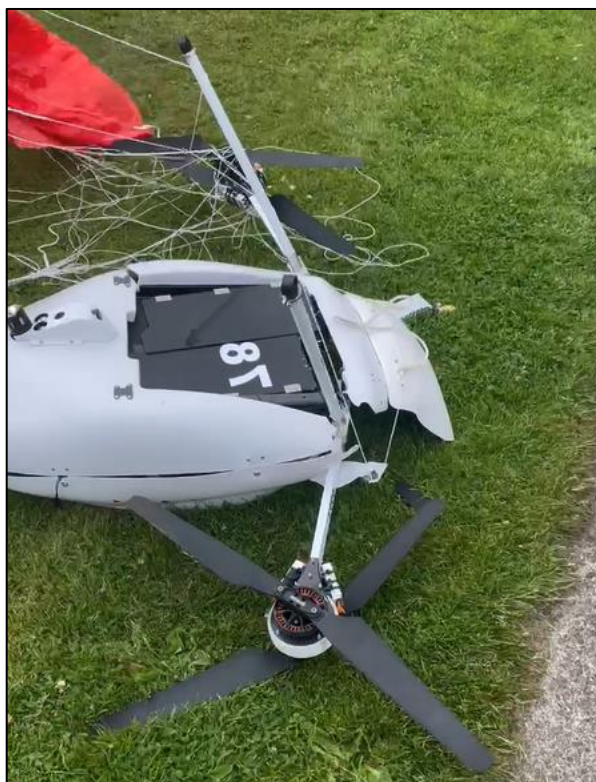
**Photo No. 3:** Final position of the UA

The UA's automatic Smart Return To Land (SRTL) feature activated in an attempt to automatically return the UA to its operating base. Due to the yaw demands commanded by the SRTL, the UA descended with a speed of 3 m per second (m/s) and the onboard monitoring system detected increasing errors in both pitch and roll axes. The UA continued to descend with the rate of descent increasing to a maximum of 8.5 m/s and all remaining motors were automatically stopped. The Flight Termination System (FTS) activated and the onboard parachute was ejected from its tube. As the UA descended through approximately 20 m, the rate of descent decreased to 4.9 m/s before the UA impacted with grassy terrain and came to rest, inverted, near a public footpath (**Photo No. 3**). The Operator initiated their Emergency Response Plan (ERP) and its personnel travelled to the accident site. The UA was video recorded in situ and subsequently recovered to the Operator's base.

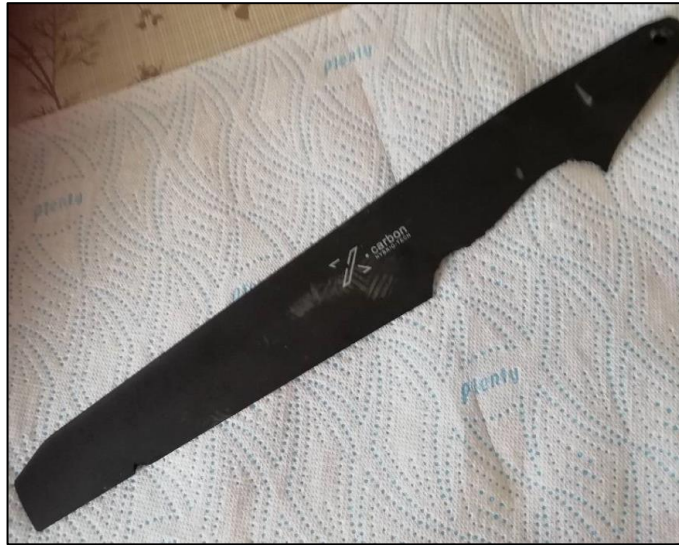
One individual informed the Investigation that he was mowing the lawn in his back garden when he was struck by what he believed to be part of a propeller from a 'drone'. He stated that he did not notice anything unusual prior to being struck due to the noise emitted from his lawn mower. He said that he sustained a small cut to his head but did not require either stitches or hospitalisation. This individual provided the Investigation with an image of what he states struck him in the head (**Photo No. 4**).

**Photo No. 4:** Image of propeller blade

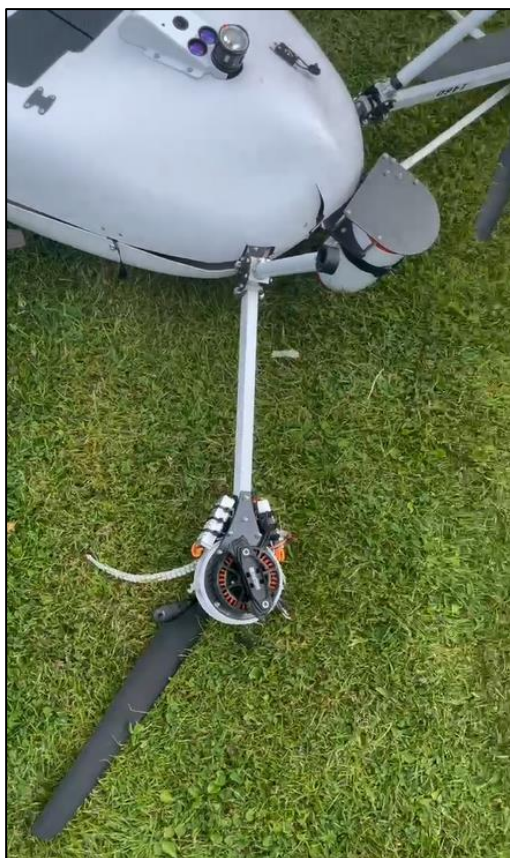
The UA sustained damage to its landing gear legs and to the arms upon which the electric motors were mounted. There was damage to the plastic outer shell and three propeller blades were missing from the rear-right arm (**Photo No. 5**).

**Photo No. 5:** Damage to plastic outer shell and missing propeller blades (UA inverted)

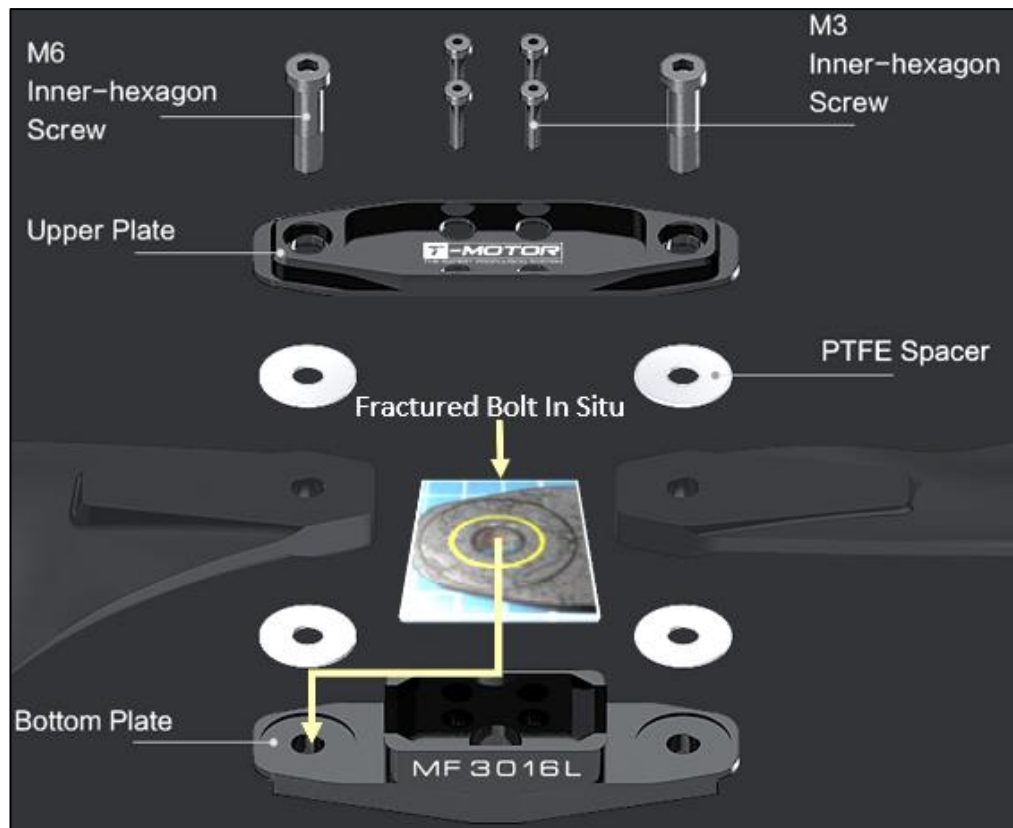
Fragments from two of the three missing propeller blades were recovered by the Operator at the scene. The Investigation noted that the missing propeller blades from the lower electric motor on the rear-right arm had fractured at their roots; however, the propeller hub and associated propeller retaining bolts, which were manufactured from alloy steel, were intact. The bolt used to secure a propeller blade to the hub on the upper rear-right electric motor was fractured and the associated blade was missing. The location of the fractured bolt is shown in **Figure No. 2** where it is described as an 'M6 Inner-hexagon Screw'.

**Figure No. 2:** Location of fractured bolt (*figure adapted from manufacturer's website*)

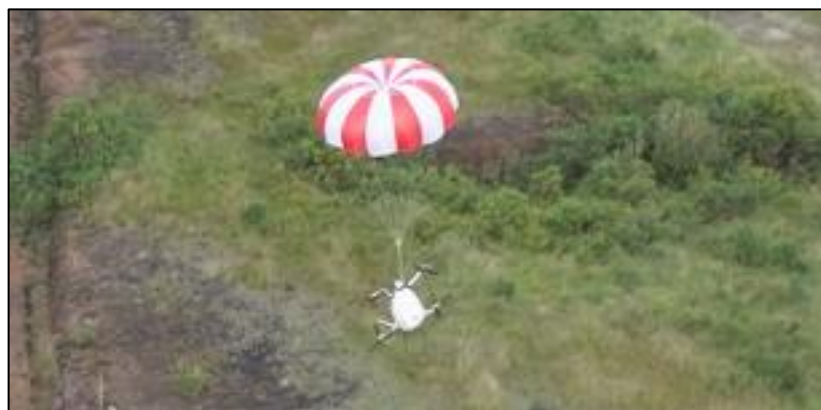
In a report provided to the Investigation following the occurrence, the Operator stated that when the parachute is deployed, the UA adopts a nose down attitude to reduce the possibility of injury to people on the ground. The Investigation viewed flight test footage provided by the Operator of two parachute deployments. One deployment was at cruise speed and the second was in the hover. In both instances, the test UA adopted a nose down attitude once the parachute was fully inflated (**Photo No.7**).

**Photo No. 7:** Still image of parachute deployment

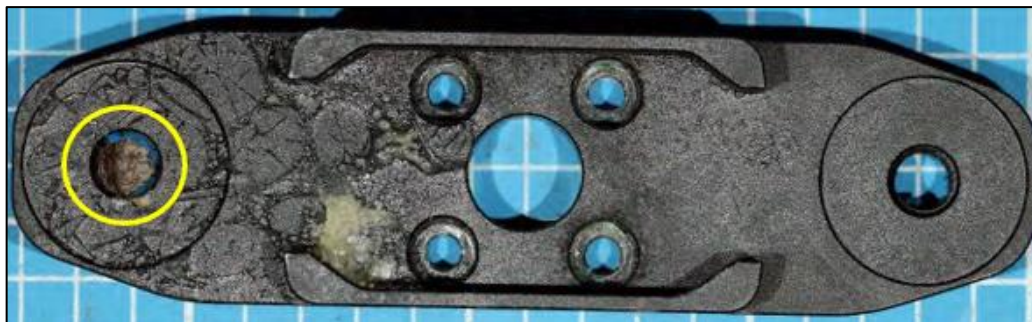
The Investigation sent the fractured propeller retaining bolt to a metallurgist for an independent detailed examination. The information contained in this section is based on this metallurgical examination. The report stated that the bolt had fractured through its threaded diameter, approximately flush with the surface of the mounting plate; surface irregularities are due to chemical treatment applied to the mounting plate prior to shipment for examination (**Figure No. 3**).

**Figure No. 3:** Fractured retaining bolt (ringed in yellow, all scale markers are 5mm squares)

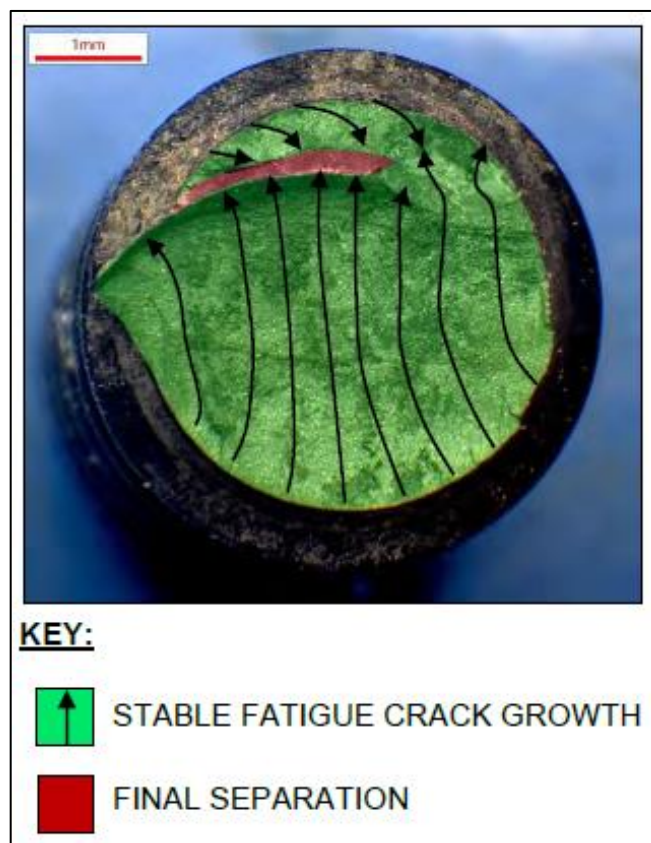
Crack progression marks<sup>12</sup> on the fracture surface indicated that the bolt had failed in fatigue<sup>13</sup> (**Figure No. 4**). Ratchet marks<sup>14</sup> around the edge of the fracture surface indicated that multiple fatigue cracks had initiated within a thread root, on opposite sides of the bolt diameter. There was no evidence of pre-existing material defects at the sites of crack initiation. The incipient fatigue cracks coalesced as they propagated inwards, forming two major fatigue crack fronts.

**Figure No. 4:** Crack progression markings

A ridge in the fracture surface identified the boundary between these two crack fronts and the region of final separation. The total surface area occupied by stable fatigue crack growth was large, in comparison with that occupied by final separation. This indicated that the fracture had occurred under the influence of cyclic stresses of relatively low amplitude, with a high number of cycles to failure (high-cycle fatigue). The metallurgist was of the opinion that this was consistent with vibrational loading.

- The bolt had suffered a fatigue fracture, which had initiated from no apparent pre-existing material defects.
- The fatigue fracture had occurred under a cyclic load spectrum of relatively low amplitude, with a high number of cycles to failure. This was consistent with vibration.
- A common cause of fatigue fractures of threaded fasteners, which are subject to vibrational loading, is insufficient assembly torque. However, it was not possible to determine the assembly torque which had been applied to the subject bolt.

Subsequent to the accident, the Operator redesigned the propeller hub with what was described as being a '*failsafe*' mechanism which would prevent the separation of a propeller blade from the hub in the event of a retaining bolt failure. The Investigation notes that this redesign involved the replacement of the manufacturer's original mounting plates (as supplied with the propellers) with mounting plates of the Operator's own design.
