# **Air Accident Investigation Unit Ireland**

**SYNOPTIC REPORT**

**Unmanned Aircraft, GEN 3.8  
Tankardstown, Balbriggan, Co. Dublin**

**14 July 2022**

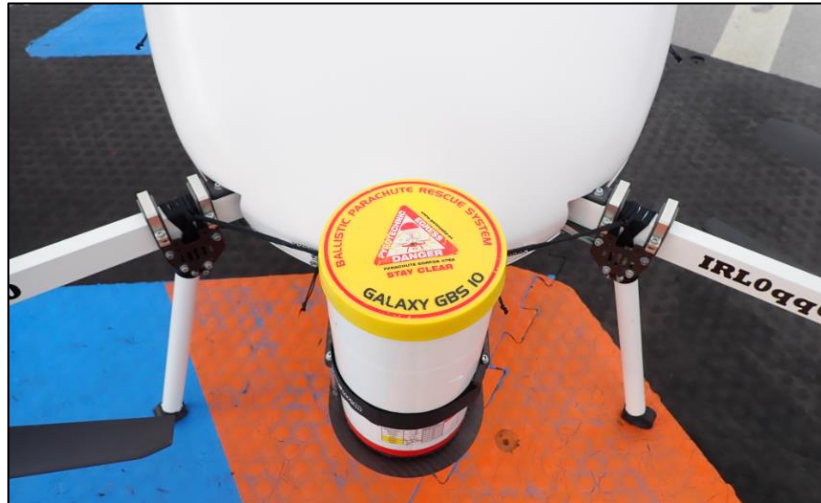
The UA was equipped with a ballistic parachute located at the rear which was designed to activate automatically on loss of control of the UA. According to the manufacturer, it is designed for an Unmanned Air Vehicle (UAV) operating in the 15-35 kg weight range. The parachute, when inflated, has a nominal diameter of 3 m and is supported by 14 lines. Activation is automatically triggered by the FTS or can be deployed manually by the RP. The parachute is contained within a tube; a 'STAY CLEAR' warning is printed on the top cover (Photo No. 6).

**Photo No. 6:** Parachute tube and warning label
